Water Compliance Inspection Report

**NPDES
Compliance Inspection Report**

Draper Valley Farm #123

February 3, 2011

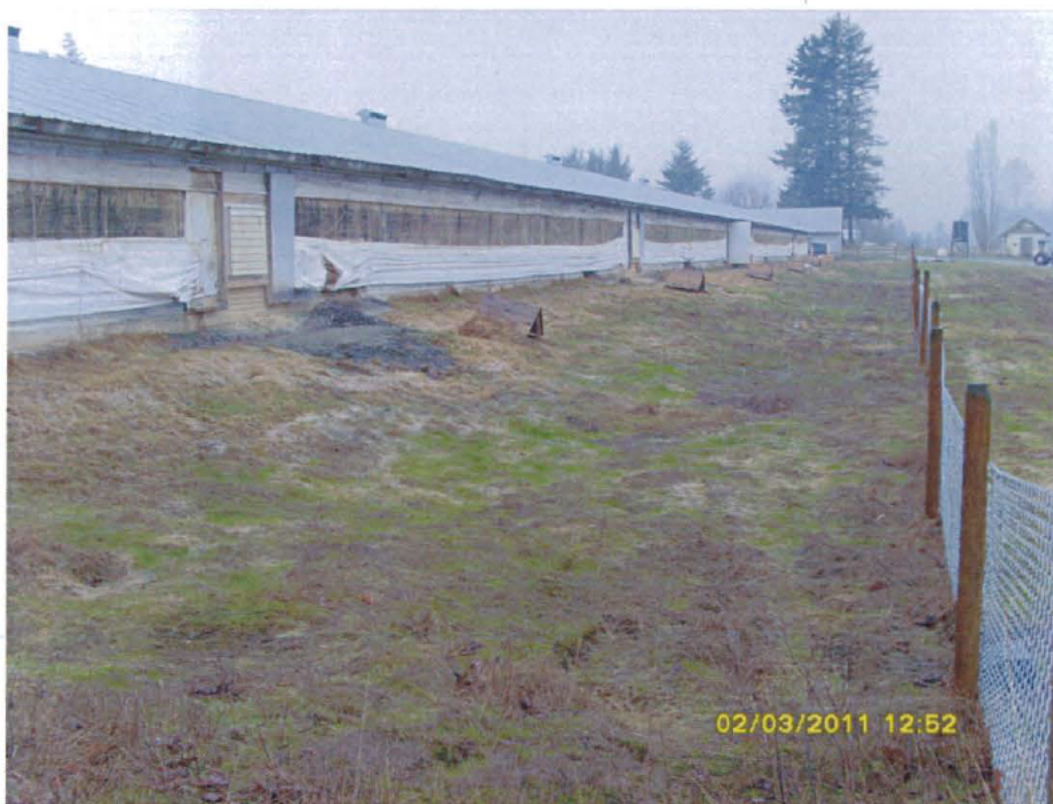
According to Jeff Power, the chickens are confined throughout the year, either in barns or in an outdoor "free range" area (photo 1). The outdoor areas are approximately 25 feet wide along the length of each of the barns. After they have reached 21 days of age, chickens are allowed outside on a weather-dependent basis.

Photo 1. Free range area along the north side of barn 2.

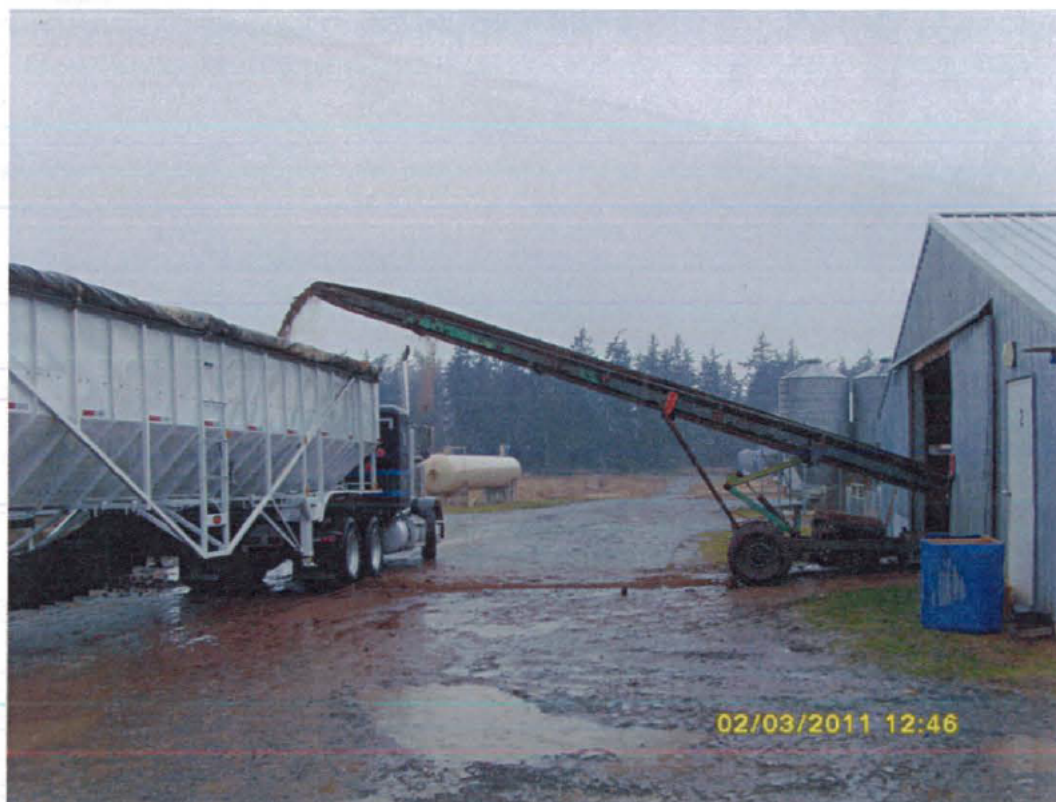
been in the barns for 6 – 7 years, except when the barn has been converted to an organic operation. Barn 2 was being converted into an organic operation at the time of inspection, so all of the litter was being removed (photos 2 and 3).

At the time of inspection, litter was being removed from barn 2 through the western entrance. The removal process involved using a track loader to load litter onto a conveyor belt that moved the litter into a truck for export. As a result of this process, litter was present on the ground beneath the conveyor belt (photo 2). The ground in front of barn 2 is slightly sloped toward the southern ditch, which is approximately 100 yards away (attachment B). There appeared to be a potential for stormwater to carry the litter in front of barn 2 into the southern ditch.

Photo 2. Conveyor belt used to move litter from barn 2 into a truck for export.

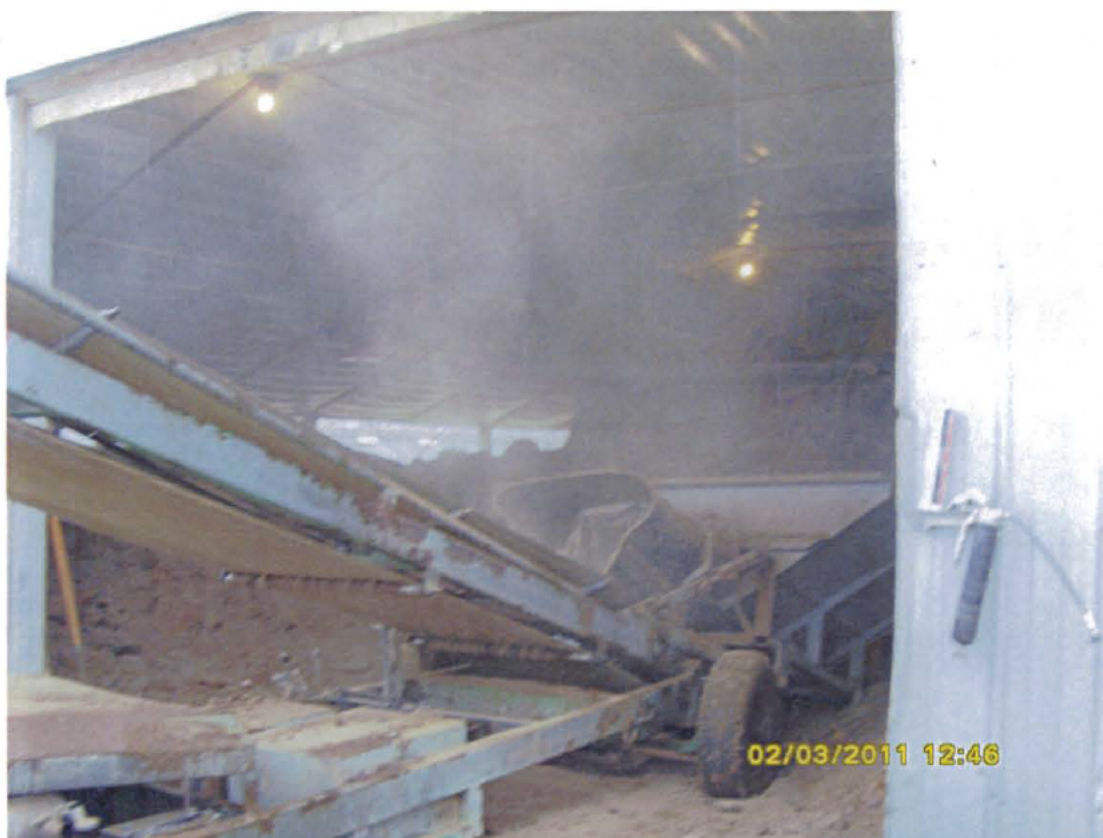
Photo 3. Conveyor belt used to remove litter from barn 2.

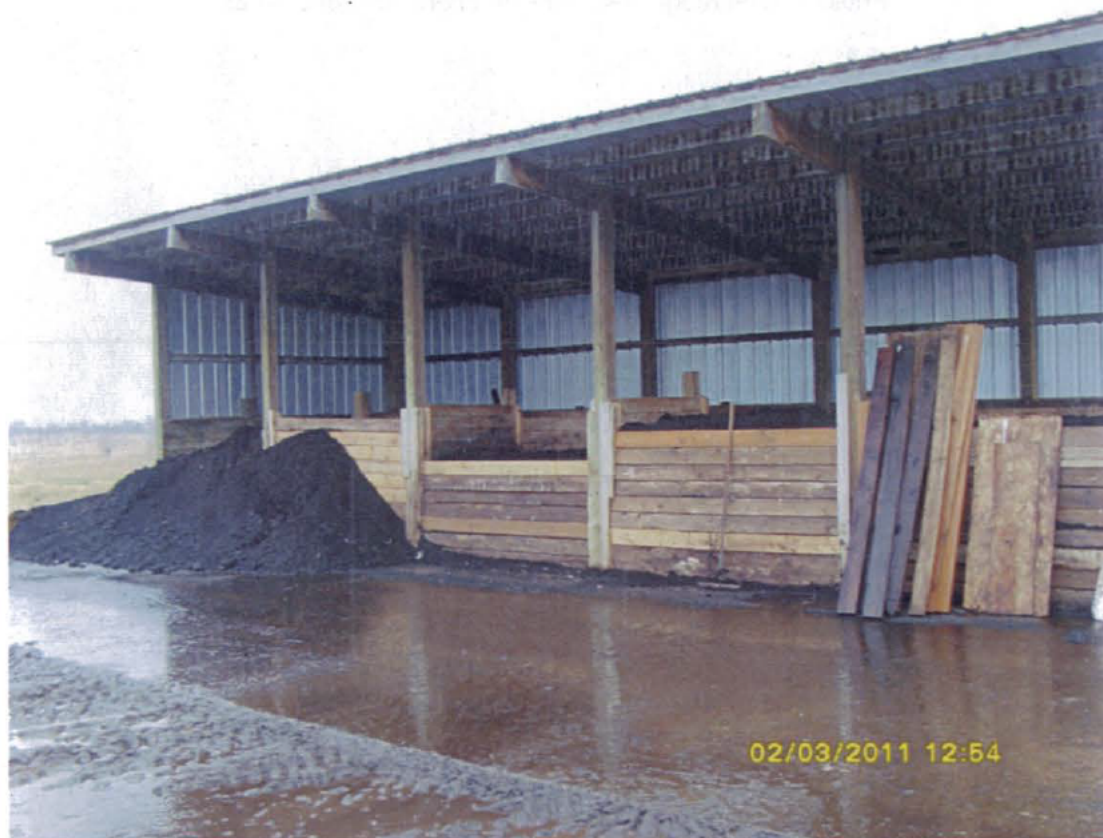
Another source of waste at this facility is material contained in the composting shed used to compost mortalities (photo 4). This composted material is also loaded into trucks and transported to High Octane.

Photo 4. Compost shed on the north side of barn 4.

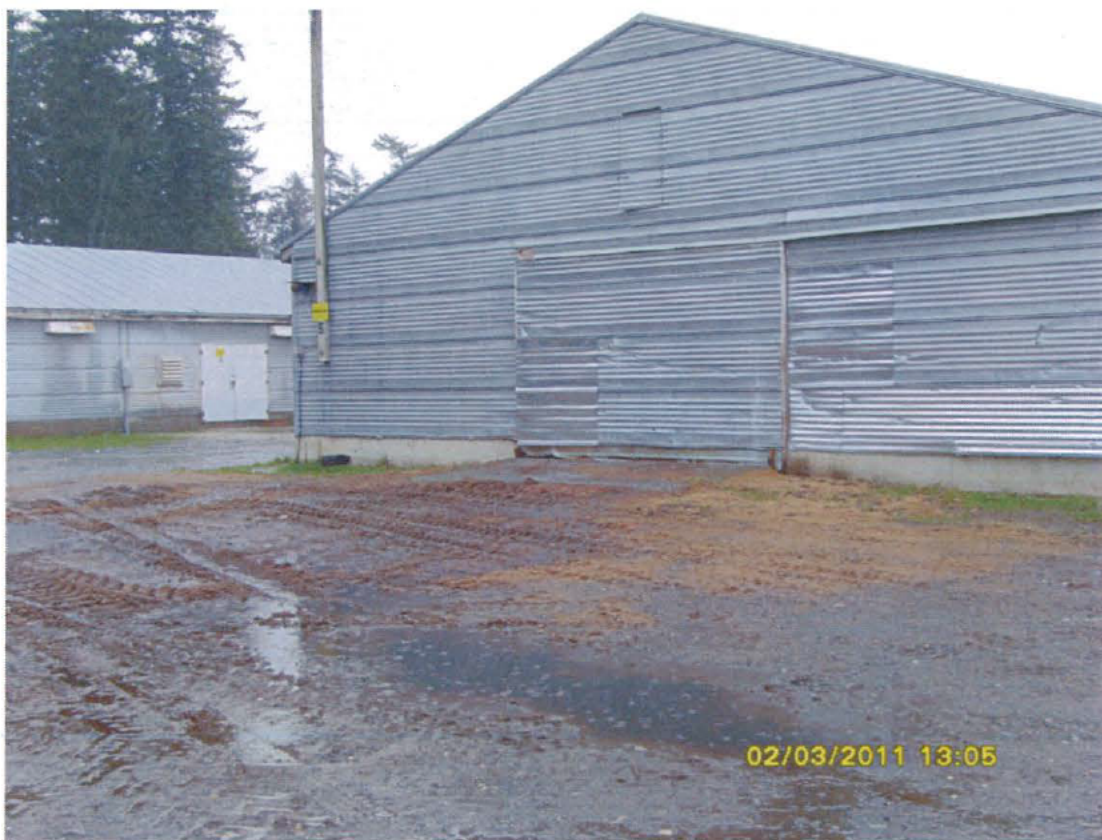
Litter was evident outside of the western entrance of barn 5. The ground in front of barn 5 significantly sloped down to the northern ditch, which is approximately 50 yards away. There appeared to be a potential for stormwater to carry the litter down the access road and into the northern ditch, which eventually flows into the Nooksack River (photos 5 – 7, attachment B).

Photo 5. Litter track out outside of barn 5.

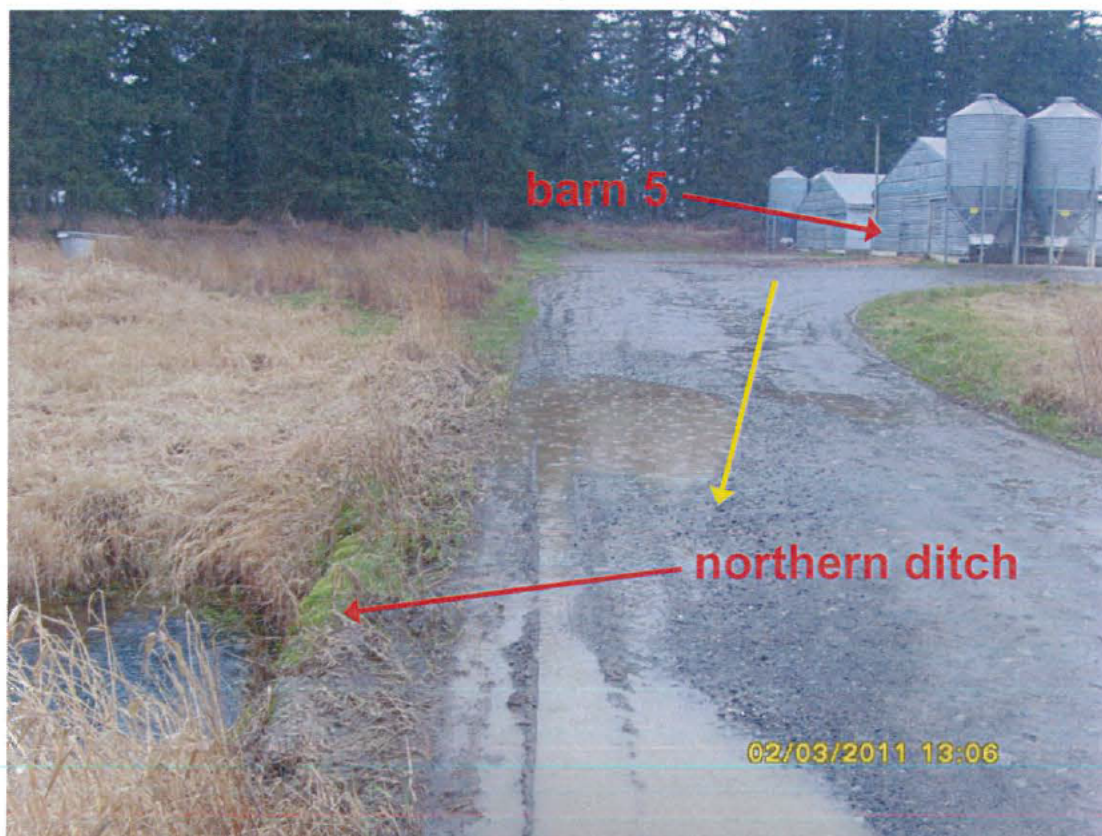
Photo 6. Relative locations and slope between barn 5 and the northern ditch.
Red arrows indicate locations and yellow arrow indicates direction of flow.

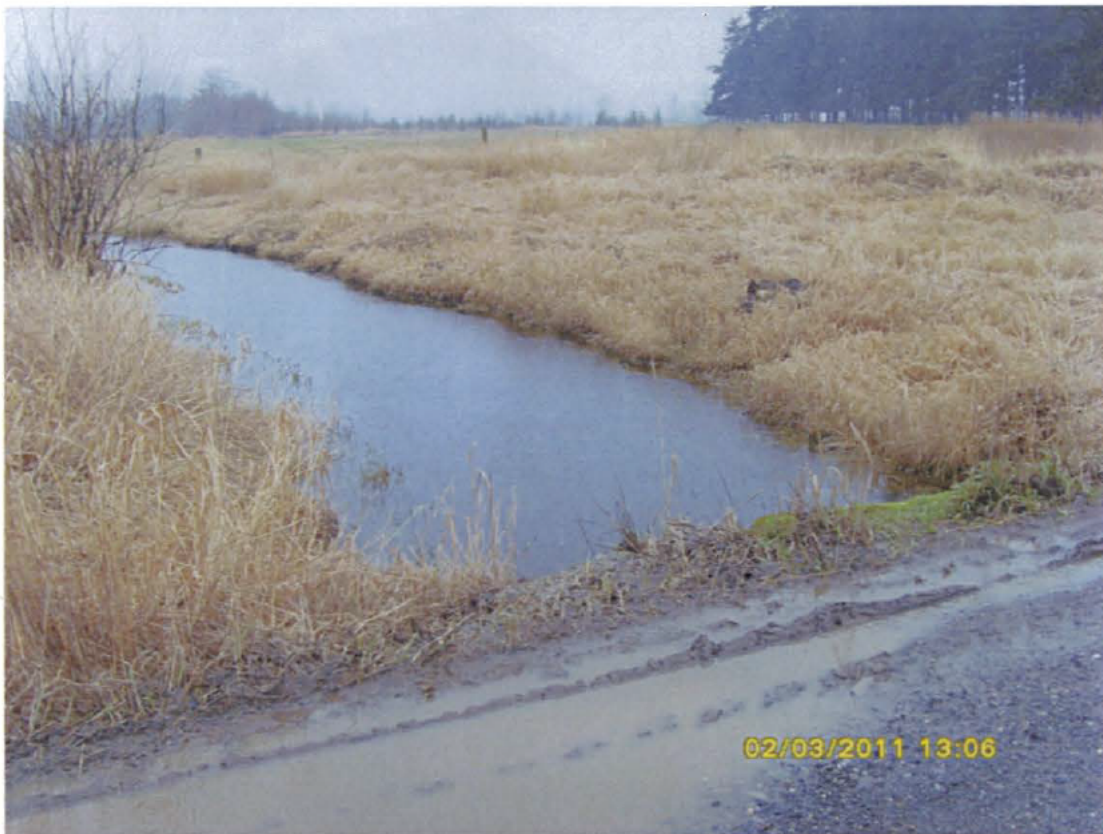
The nearest surface water is two ditches that flow between barns 4 and 5. Along the western side of the facility property, the southern ditch is routed to combine with the northern ditch (attachment B). According to Google Earth Pro aerial images, approximately 8 miles downstream, this ditch (which becomes a creek) flows into the Nooksack River. At the time of inspection, water in the northern ditch did not appear to be flowing.

Photo 7. Northern ditch that flows to the west from the facility. At the time of inspection, the water in the ditch did not appear to be flowing.
